Re: BIP 40 LLC
Williston Village RV Resort
Section 24, T155N, R101W
Williston, Williams County, ND

WETLAND MITIGATION PLAN

Williston Village RV Resort
Section 24, T155N, R101W
Williams County, North Dakota
Project #4554

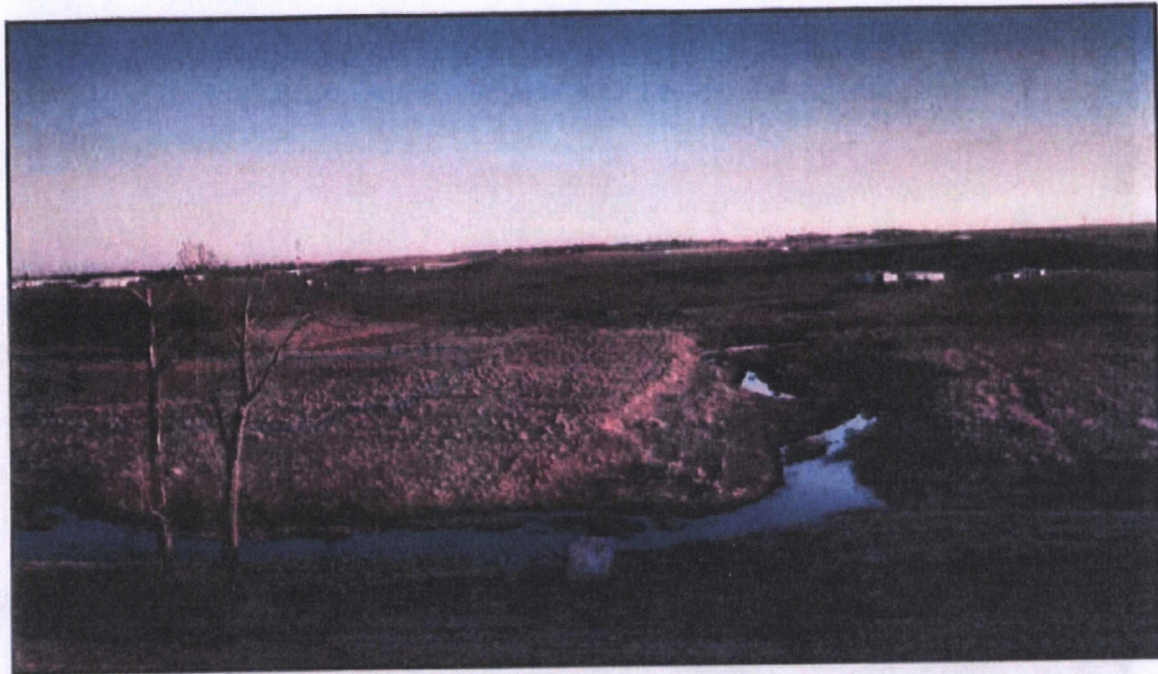
Photograph 1 – Mitigation Site 1

Photograph taken facing south toward the RV Resort. Mitigation Site 1 is an upland area adjacent to Camp Creek. Crested wheatgrass is the primary vegetation on the site. Excavation of the site would allow inundation by high flows back-flooding into it from Camp Creek. The high flows would also bring hydrophytic vegetation seeds into the mitigation wetland. The blue line indicates the approximate location and shape of Mitigation Site 1.

Two sites adjacent to Camp Creek and its associated wetlands have been selected for mitigation. Both sites consist of upland soils and vegetation but are immediately adjacent to Camp Creek and its associated wetlands. Both sites would be periodically inundated by high flows.

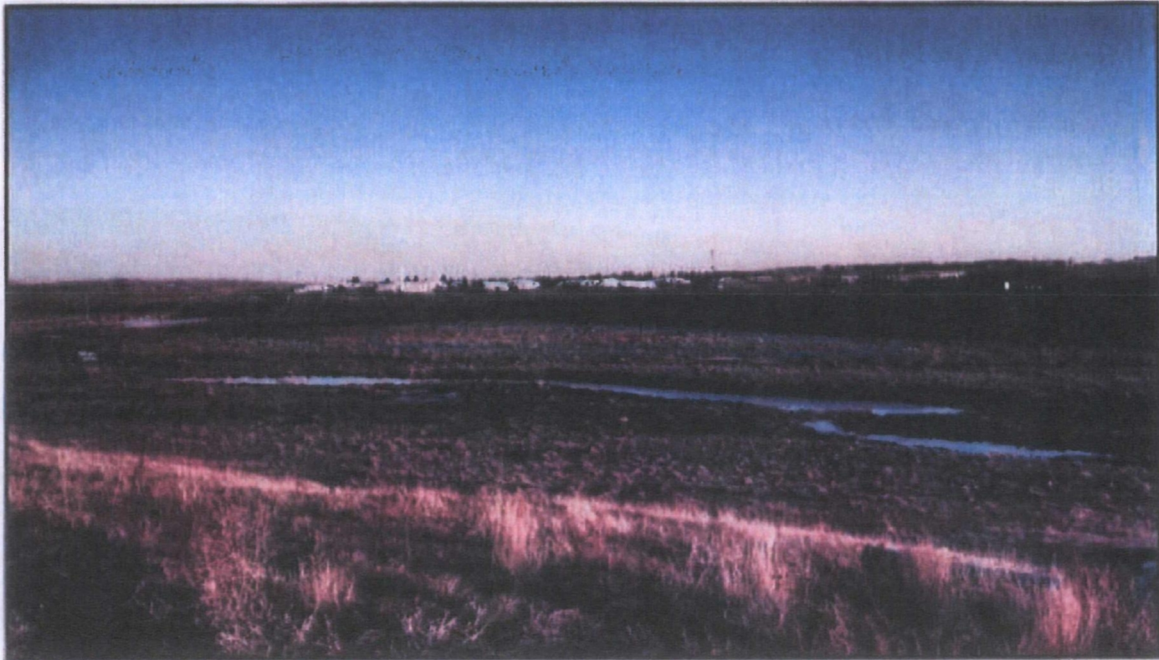
Photograph 2 - Mitigation Site 2

Photograph taken facing south toward the east side of the RV Resort. The mitigation site is a low elevation upland area adjacent to the associated wetlands of Camp Creek. Crested wheatgrass and western wheatgrass are present on the site. Excavation of the site would allow inundation and saturation from the adjacent wetlands. The adjacent wetlands would also be a source of hydrophytic vegetation seeds. The blue line indicates the approximate location and shape of Mitigation Site 2.

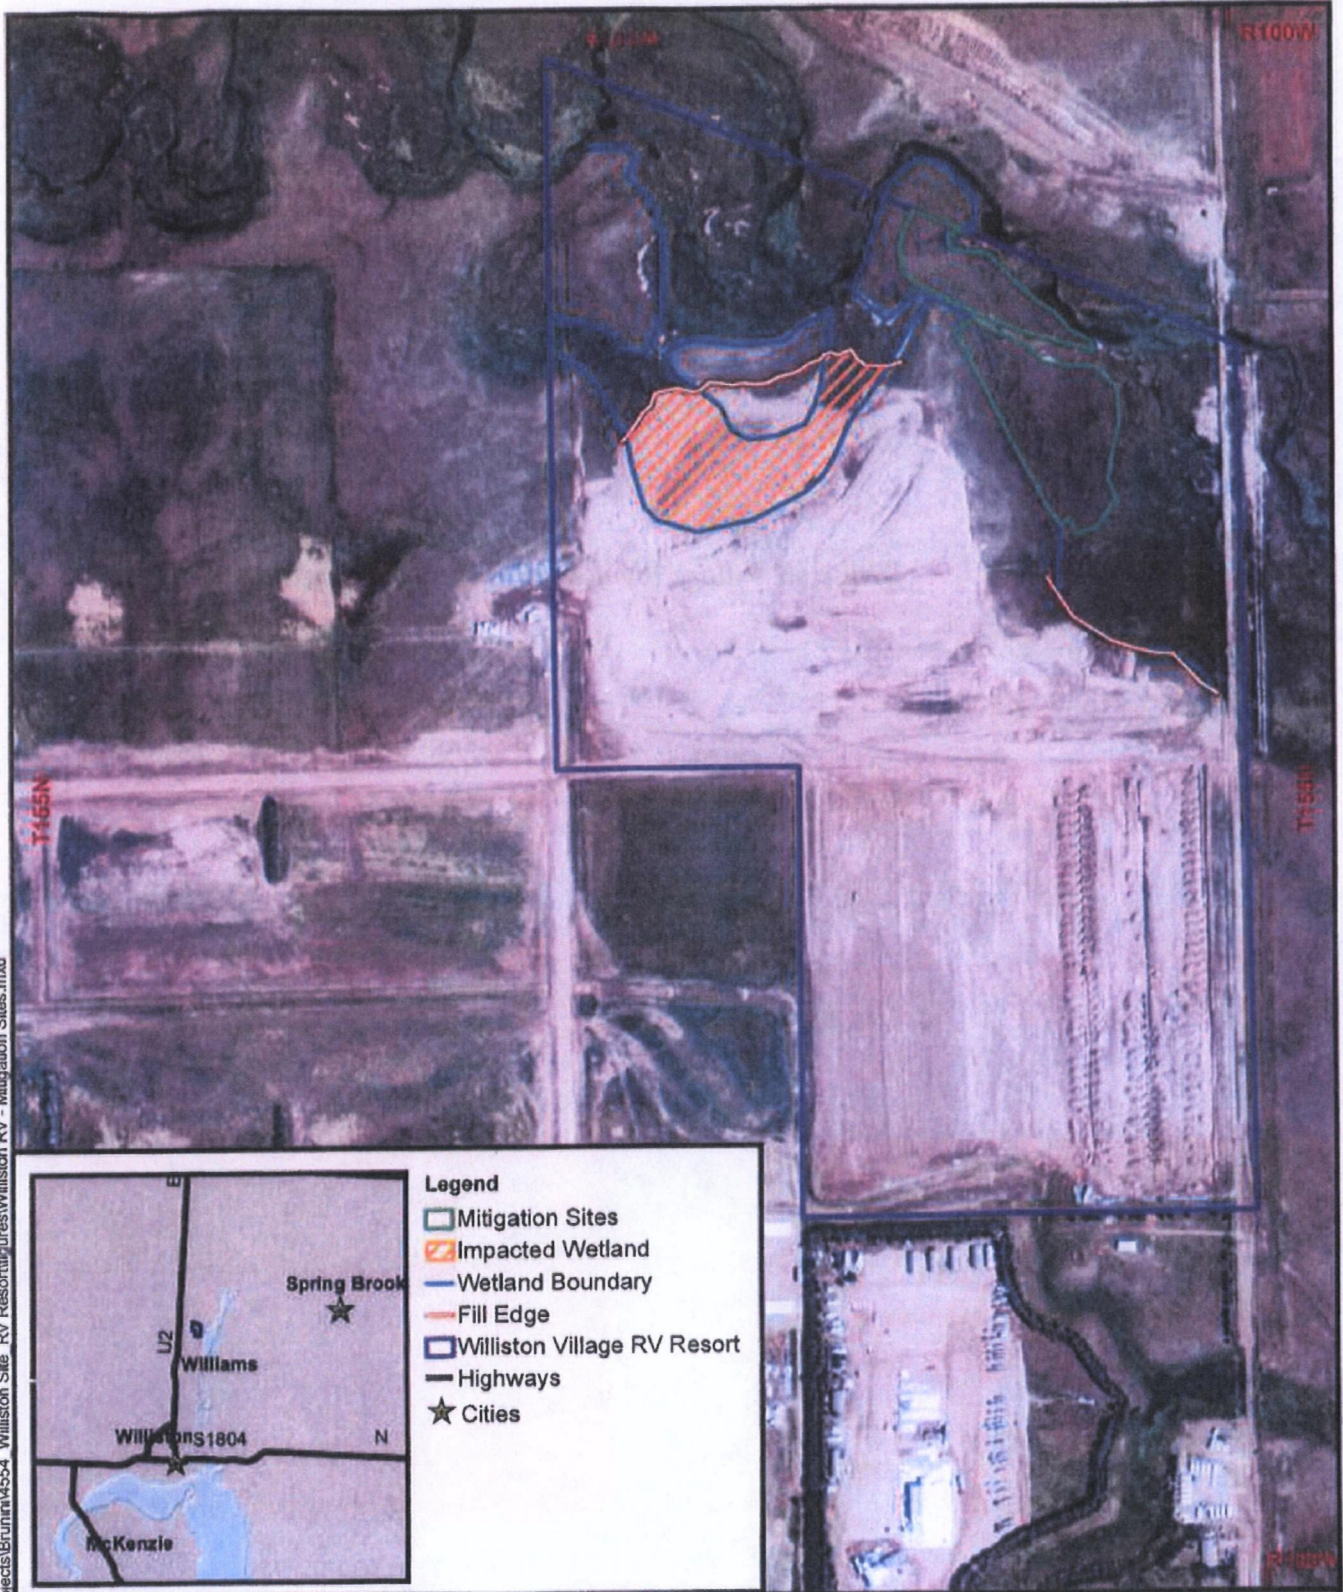
E:\Projects\Brunna\4554 Williston Site RV Resort\figures\Williston RV - Mitigation Sites.mxd
June 2013

The mitigation area is located in the northeast corner of the RV Resort, approximately 235 feet from the impacted wetland area. The mitigation area will be adjacent to Camp Creek that flows into the Little Muddy River, which in turn flows into Lake Sakakawea.

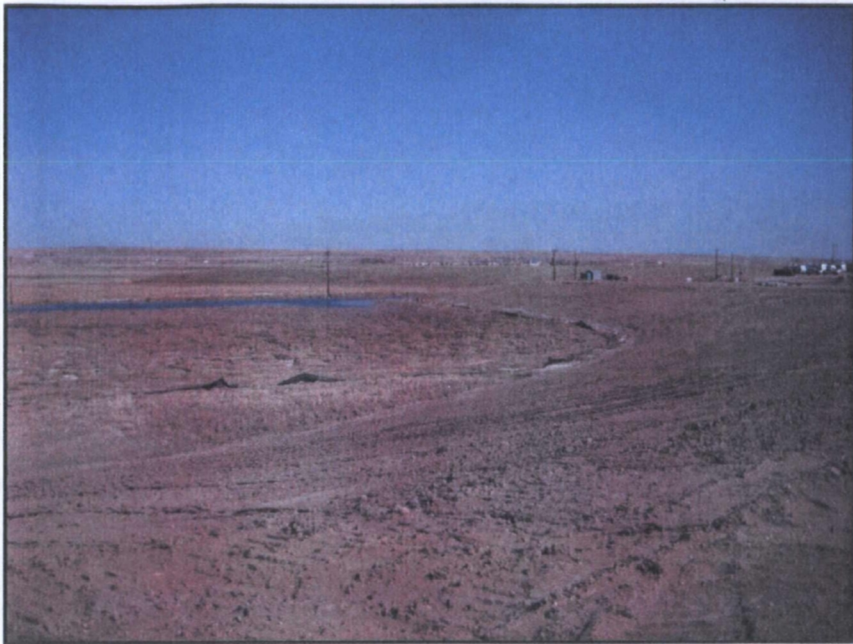
Photograph 1. Photograph of Williston Village RV Resort fill materials up to wetland edge. The wetland is located within the floodplain of Camp Creek. The sediment fence is located along the wetland boundary. Photograph taken facing southeast.

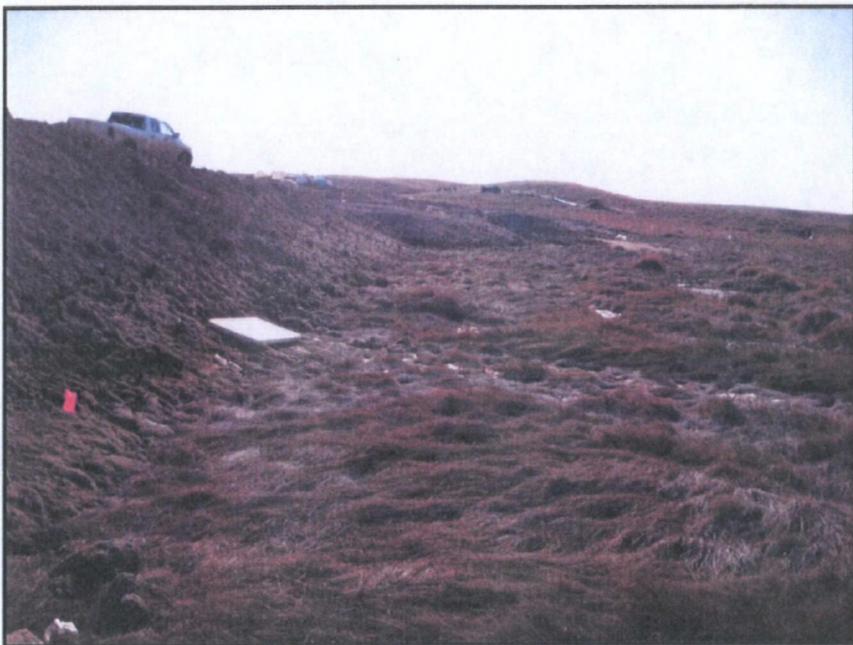
Photograph 2. Photograph of impacted wetland. The wetland consists of a former oxbow / meander channel of Camp Creek. Approximately 4.5 acres of wetland have been impacted by the construction of the RV Resort. Photograph taken near-to observation point 1w2 and facing west.

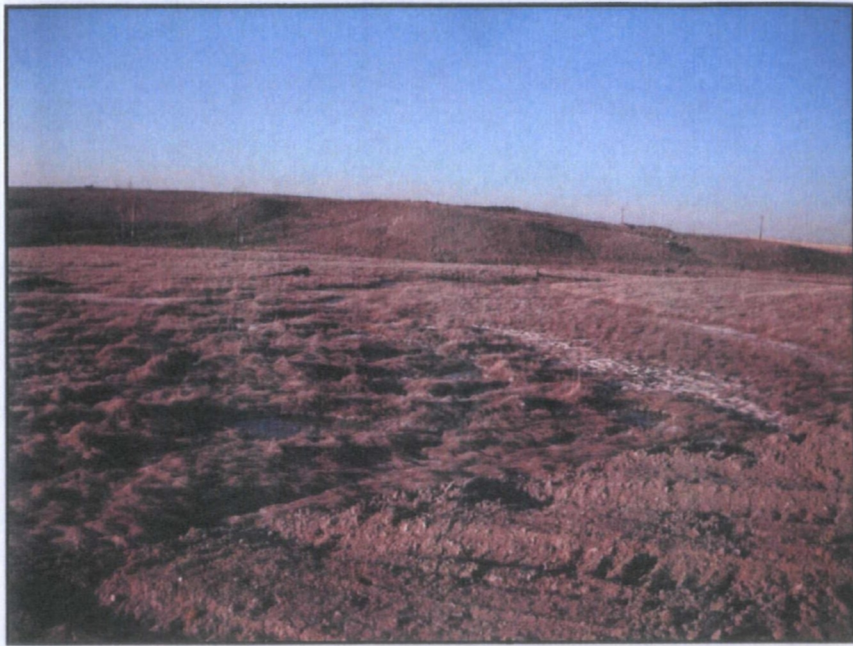
Photograph 3. Photograph overlooking impacted wetland. Photograph taken facing north.
